**Herring Run Sewershed Evaluation Study Plan
Project 1001**

**Sewershed Study and Plan Report
Sanitary Sewer Overflow Consent Decree
Civil Action No. JFM-02-1524**

June 2009

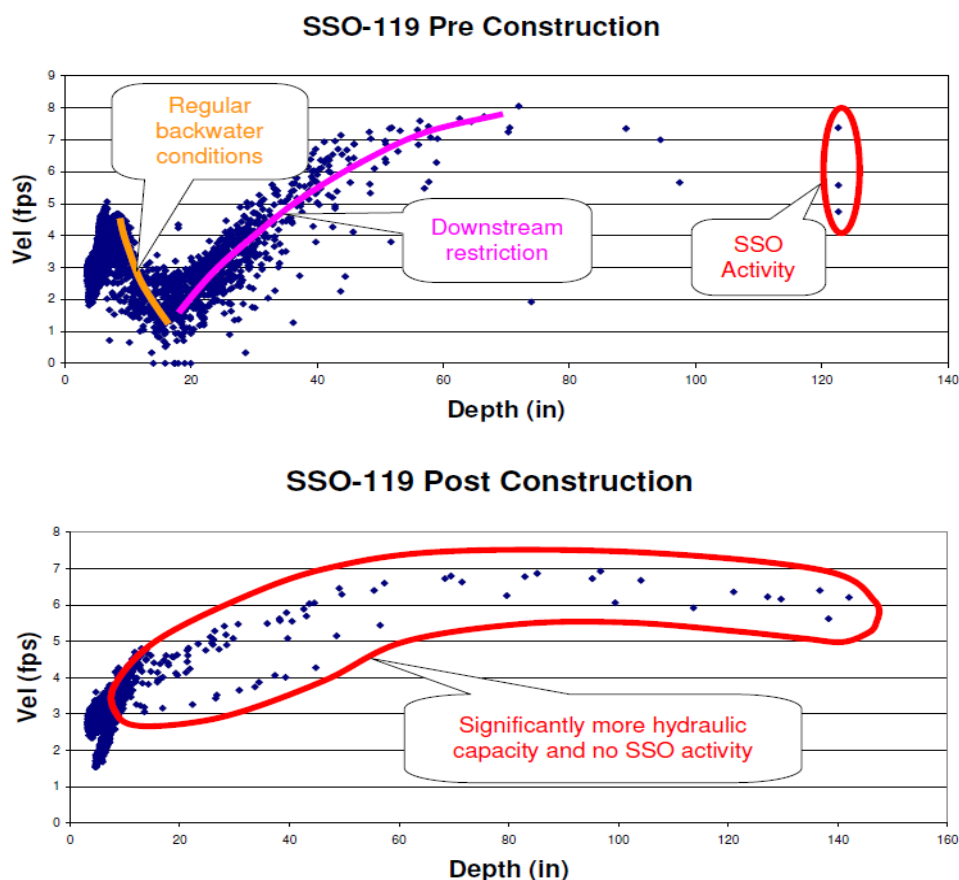
Figure 2.3.1 – Pre and Post-Construction Scattergraphs for SSO#119

Due to the circumstances explained above, the efficacy of the construction projects cannot be assessed readily with pre and post-construction flow monitoring data. However, an assessment can be made at SSO #119. Flow data for SSO #119 shows a significant hydraulic improvement post construction. Figure 2.3.1 below indicates regular backwater conditions and downstream SSO activity before construction (top scattergraph), and a significant increase in system capacity and no SSO activity after construction (bottom scattergraph).

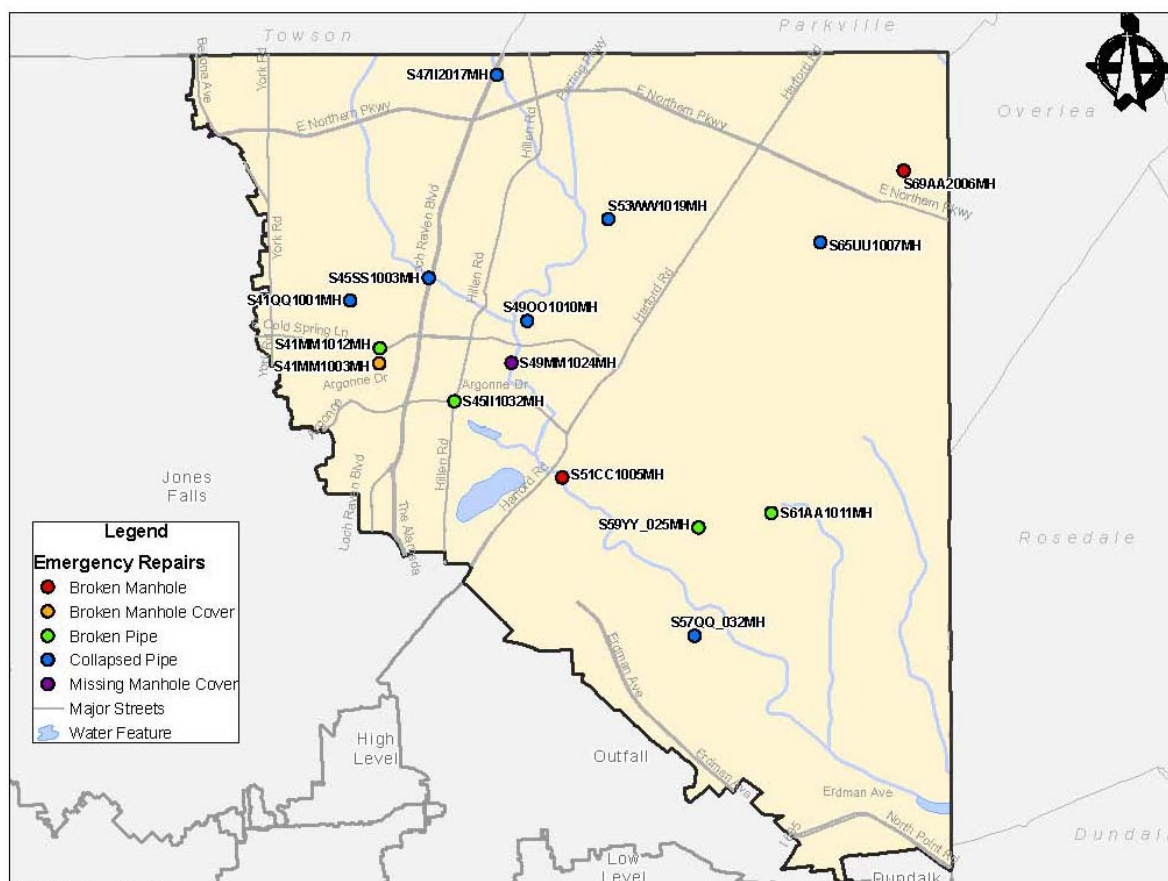
Figure 4.6.1 – Emergency Repair/Rehabilitation Locations

In accordance with Paragraph 9 Item C.iii of the Consent Decree, all significant system deficiencies observed during field inspections or when reviewing the field data were reported to the City. Figure 4.6.1 indicates the location of reported observed significant deficiencies.

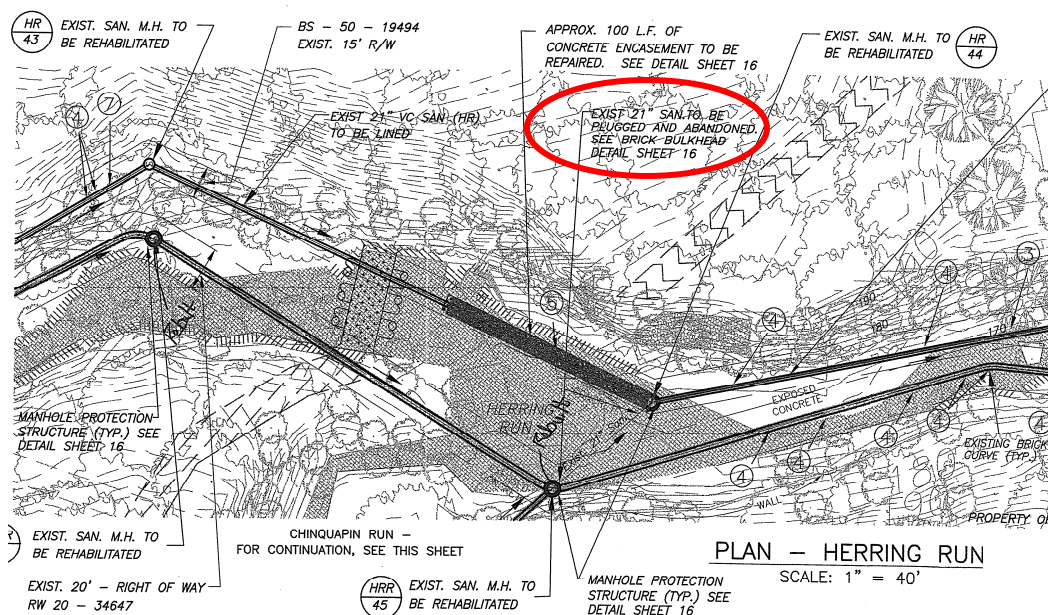
**Figure 5.4.1 – Abandonment of Chinquapin Run Interceptor
(from SC 761R record drawing W.W.D. 80-49791)**

When the Herring Run Relief Interceptor was constructed, a segment of 21-inch diameter sewer was abandoned (reference Figure 5.4.1), which connected the Chinquapin Run Interceptor into the original Herring Run Interceptor. Hydraulic simulations indicate that the flows between the two Herring Run Interceptors, where the Chinquapin Run Interceptor currently discharges into the Herring Run Relief Interceptor, are unbalanced. It is recommended that the abandoned 21-inch diameter sewer be reinstated to balance flows between the two Herring Run Interceptors and prevent overflow conditions in the Chinquapin Run Interceptor. Since the existing condition of the 21-inch diameter sewer is unknown, it was assumed that some structural rehabilitation will be required. The hydraulic model conservatively assumes the re-instated sewer will be 18-inch diameter to account for sliplining the existing sewer. The estimated cost for this recommendation is approximately \$39,000.

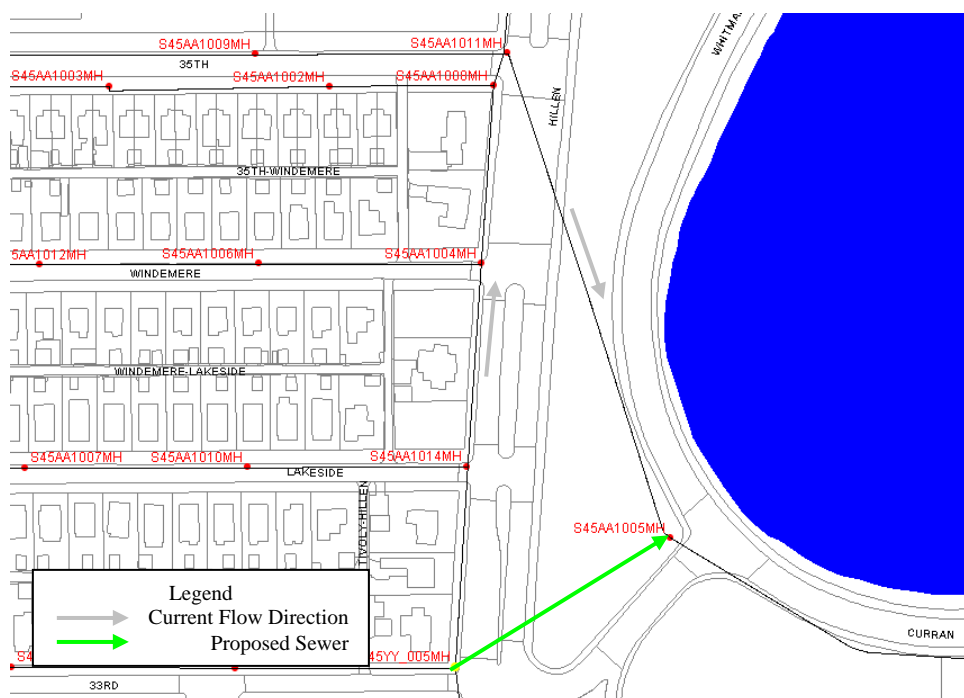
Figure 5.4.2 – Proposed Tiffany Run Hydraulic Improvement

Excessive I/I, recorded at flow meter HR10, produced SSOs at three separate locations during the 2-yr design storm event. It is recommended to perform CIPP lining of all the sewers and rehabilitate all of the manholes in four of the sub-catchments (identified as 33-11-02-02A, B, C and D) located in the southern section of the Tiffany Run sub-sewershed. Due to existing sewer configurations, the sewer between S45AA1008MH and S45AA1011MH discharges in a direction opposing the direction of flow conveyed by the Tiffany Run Interceptor; thereby resulting in surcharged conditions (reference Figure 5.4.2). Therefore, a new 10-inch diameter sewer between S45YY_006MH and S45AA1005MH is recommended to improve hydraulic conditions.

The estimated cost to complete all hydraulic recommendations in the Tiffany Run sub-sewershed is approximately \$1,000,000.

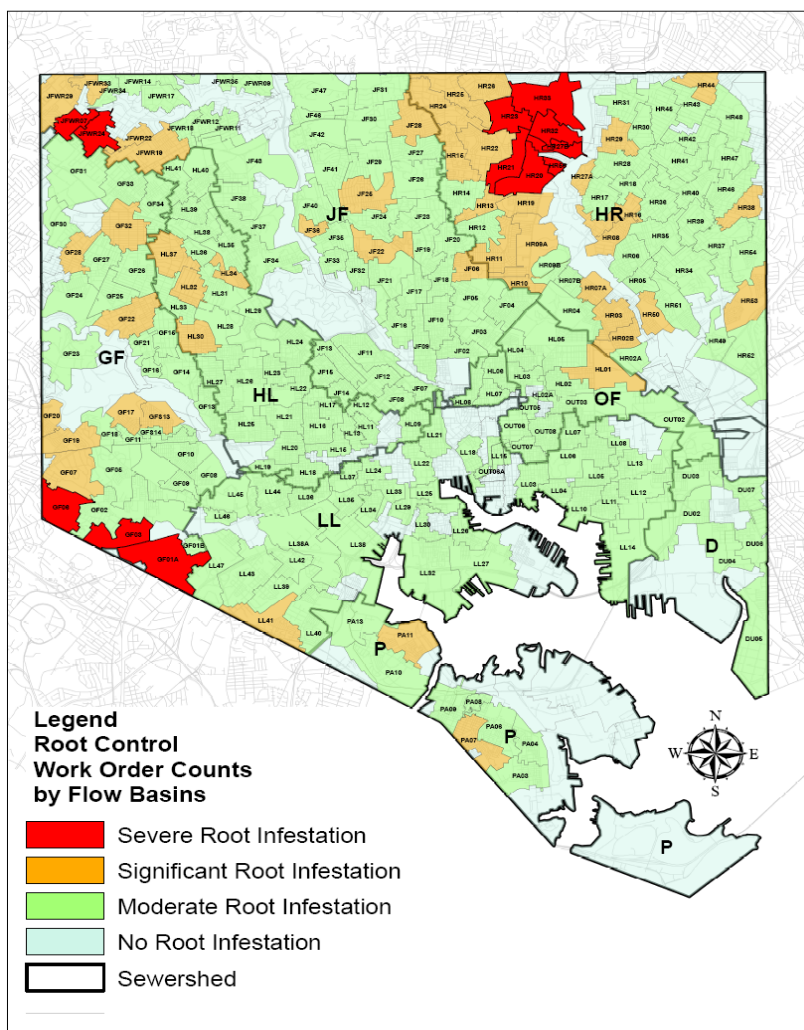
Figure 7.6.1 – Root Control Analysis

In 2004, under Project 1015, the City began monitoring the impacts of root infestation in their collection system by tracking and geocoding customer calls related to root problems in the sewer. In 2006, the City identified an area in the Herring Run Sewershed having severe root intrusion problems (approximately 1,500 acres, 230,000 linear feet of pipe). The City proceeded to implement a root control chemical application pilot project in this area in 2007, which included the treatment of approximately 150 house laterals and service connections. The pilot project yielded promising results. The City is therefore expanding the Root Control Program (RCP) into other areas of the collection system with documented root intrusion problems. A recent evaluation of customer calls in 2007 identified two additional areas with severe root infestation (see Figure 7.6.1).

To evaluate the effectiveness of the on-going root control program, the Project 1015 Technical Manager will use other sources of information, such as CCTV and manhole inspections, will be used to validate and direct the root control efforts. The goal of the on-going RCP is to treat all areas of the collection system experiencing root infestation once every three to five years. The effectiveness of the RCP will be assessed by continued monitoring of the areas and continuous evaluation of customer complaint calls within these areas on a six month review basis.
